PRESERVATION ASSESSMENT OF THE LYNNHAVEN HOUSE CEMETERY, VIRGINIA BEACH, VIRGINIA

Chicora Research Contribution 554

Prepared By:
Michael Trinkley, Ph.D.
and
Debi Hacker

August 2013

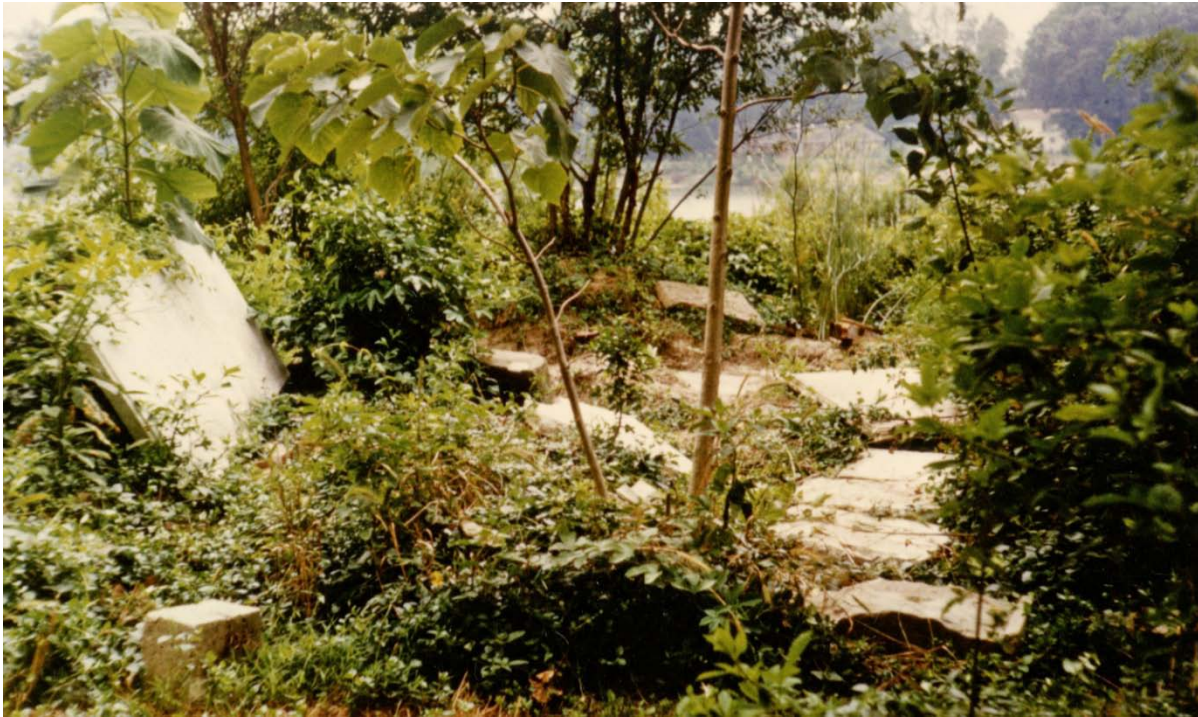
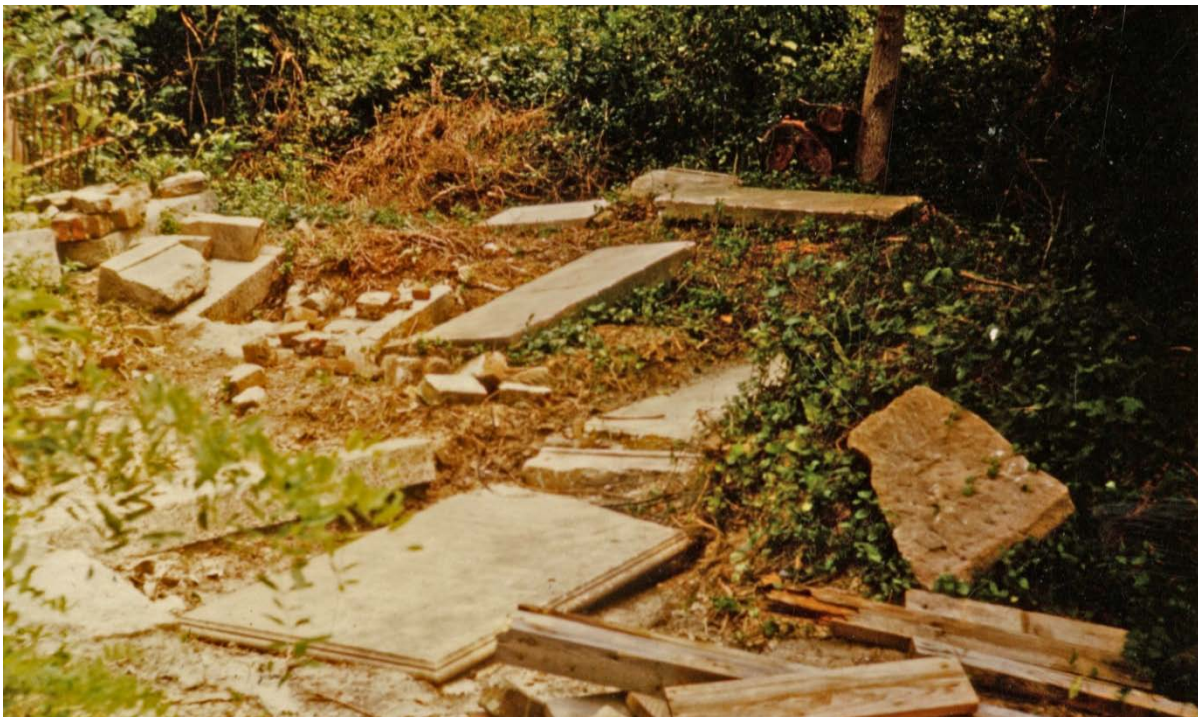
A series of photographs dated July 1975 reveal the cemetery to be in ruins. They reveal dense, but scrubby or second growth vegetation covering the burial area. The marble box tombs are all disassembled, broken, and scattered across a 30 to 40 foot area. The cemetery appears to have suffered extraordinary vandalism, although we

Figure 9. Condition of the Lynnhaven House Cemetery in July 1975. The upper photograph shows the cemetery, probably after clearing, looking south toward the man-made Lake Wishart. The lower photograph shows the cemetery looking east (City of Virginia Beach Department of Museums).

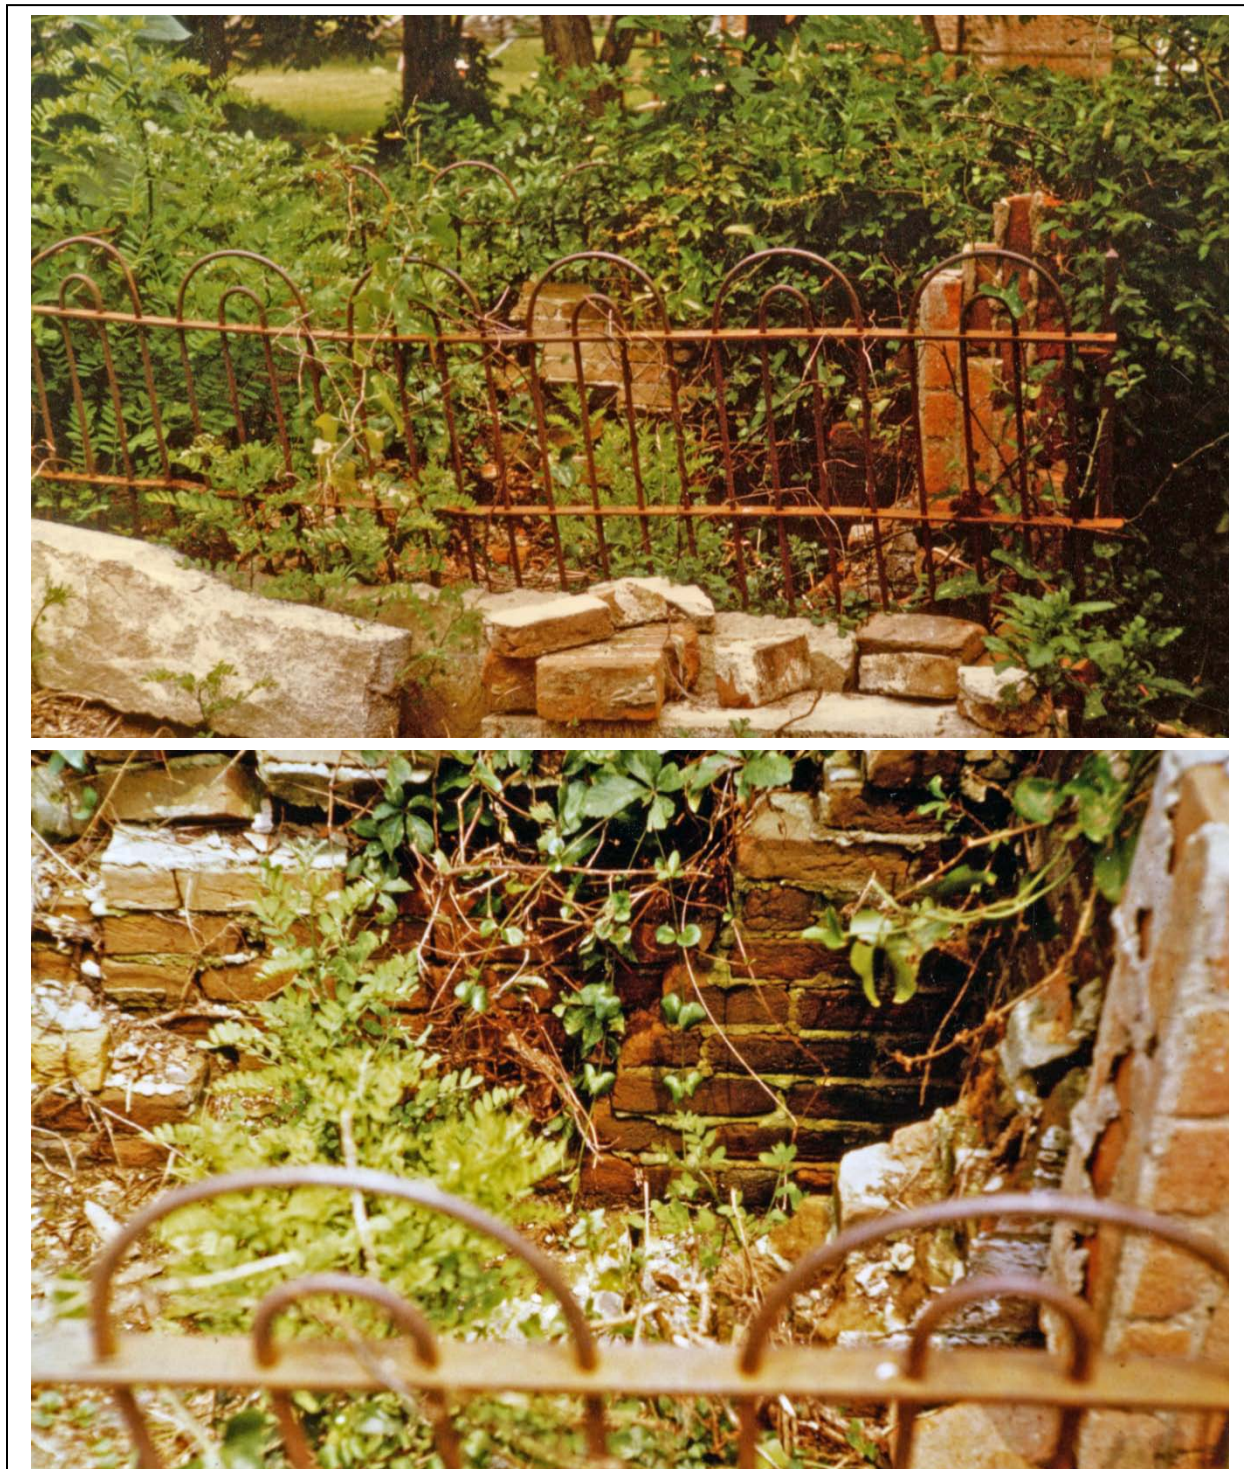
Figure 10. Condition of the brick box tomb and fence in July 1975. The upper photograph is looking north toward the house (in the background). The lower photograph is a close-up of damage (City of Virginia Beach Department of Museums).

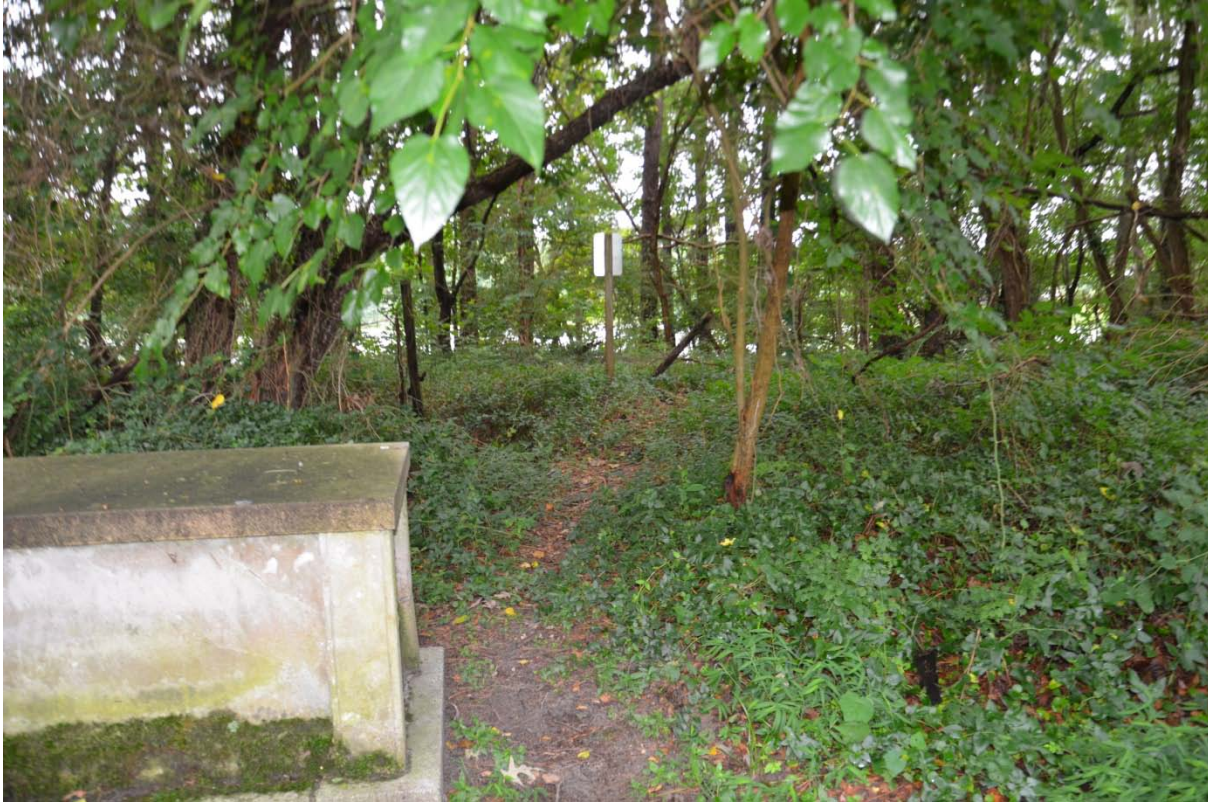
Figure 18. Social path from the cemetery southward to the property fence and Wishart Lake.

The presence of a social path leading from the cemetery to Wishart Lake (Figure 18) may be the only suggestion that individuals from outside the park are making their way through the cemetery.

It is important to extend a pathway to the cemetery, clearly marking the access route for pedestrians, directing them to appropriate signage, and ensuring that they avoid areas of below ground vaults. It is also important to eliminate the social pathway leading to the fence. This can perhaps be achieved by a combination of repairing the existing property fence and placing an obstacle such as a log along the route to discourage its use, changing pedestrian behavior.

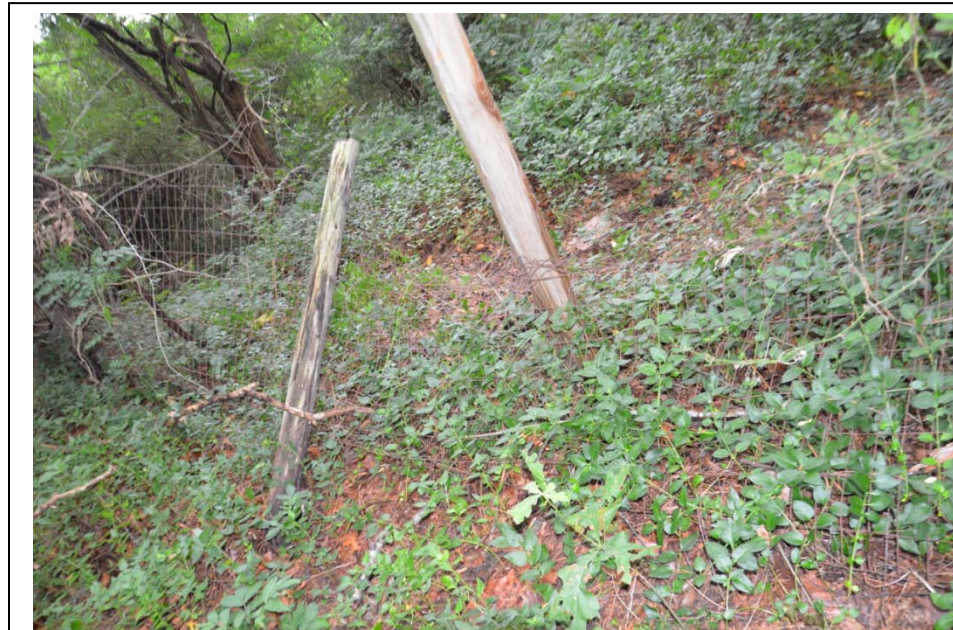
Figure 20. Dilapidated fence at the boundary between the cemetery and Wishart Lake. This fence should be replaced.

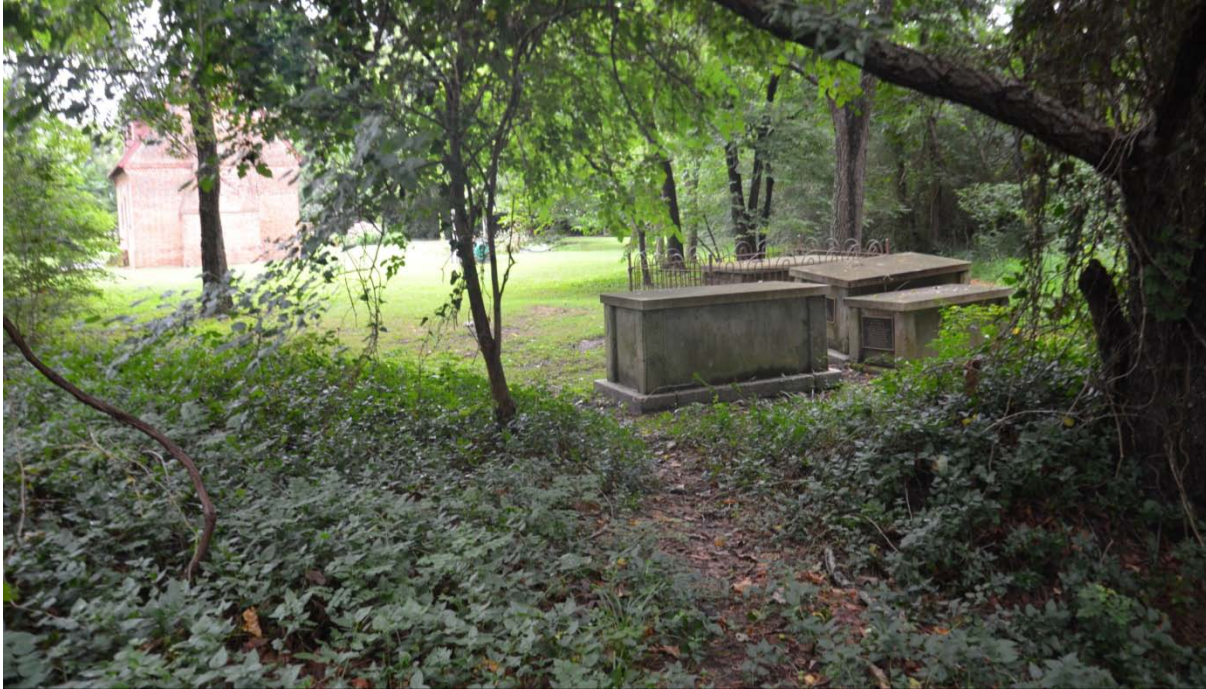
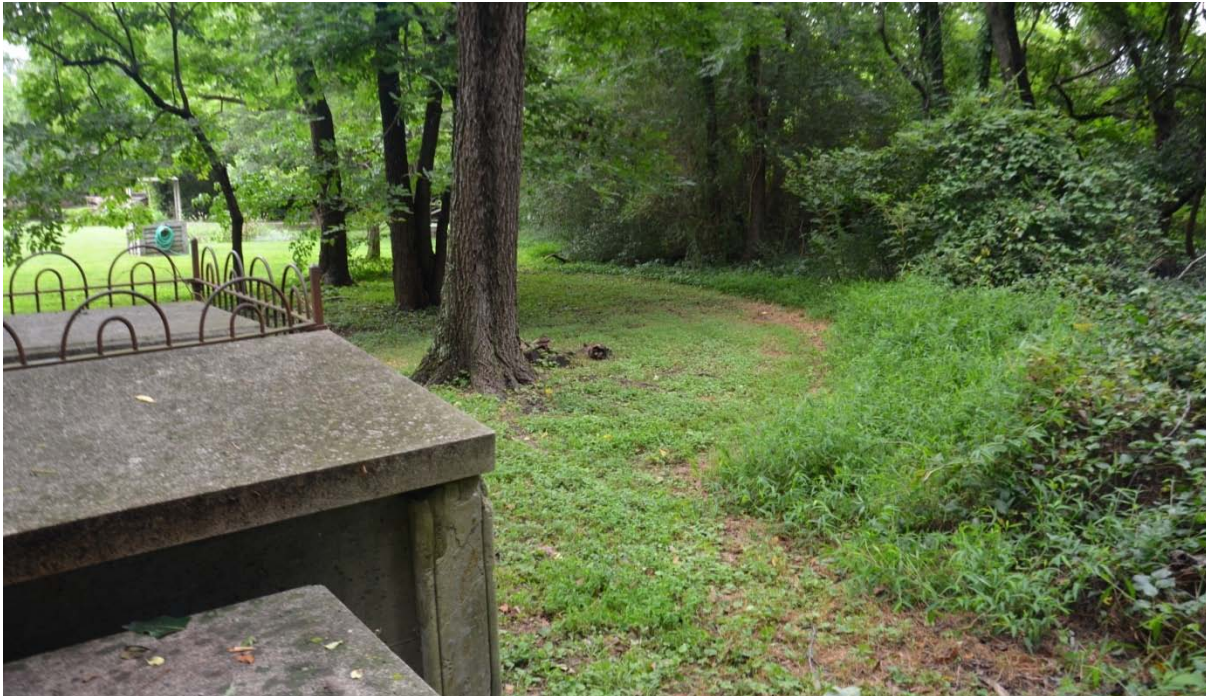
Figure 23. Vegetation requiring removal from around the cemetery. These photographs show the vegetation on the south, east, and west sides that should be pushed back to open the cemetery, giving it a more pleasing and attractive appearance to visitors.

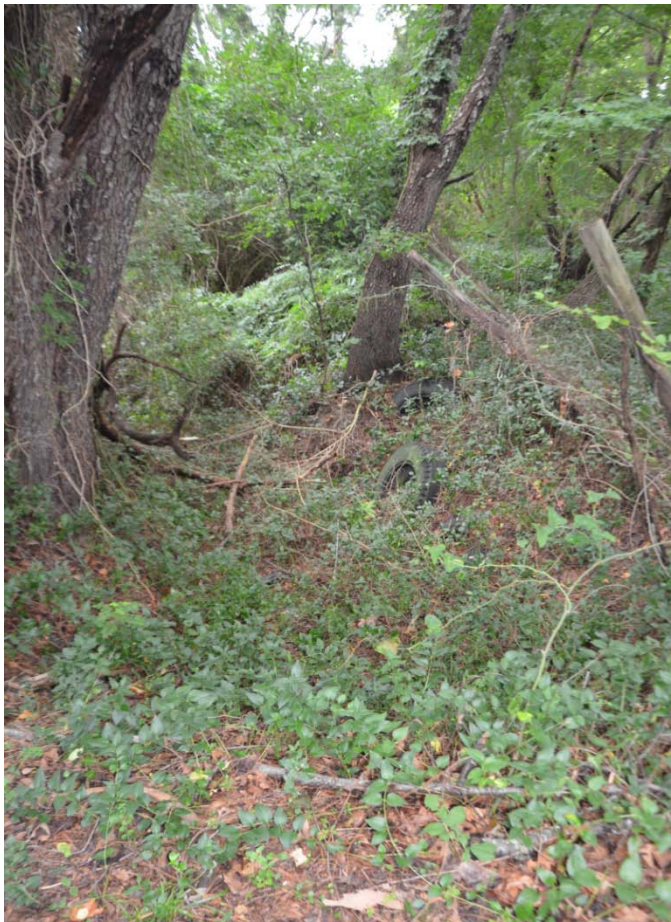
Figure 26. Ditch showing trash and dense vegetation. View to the east.

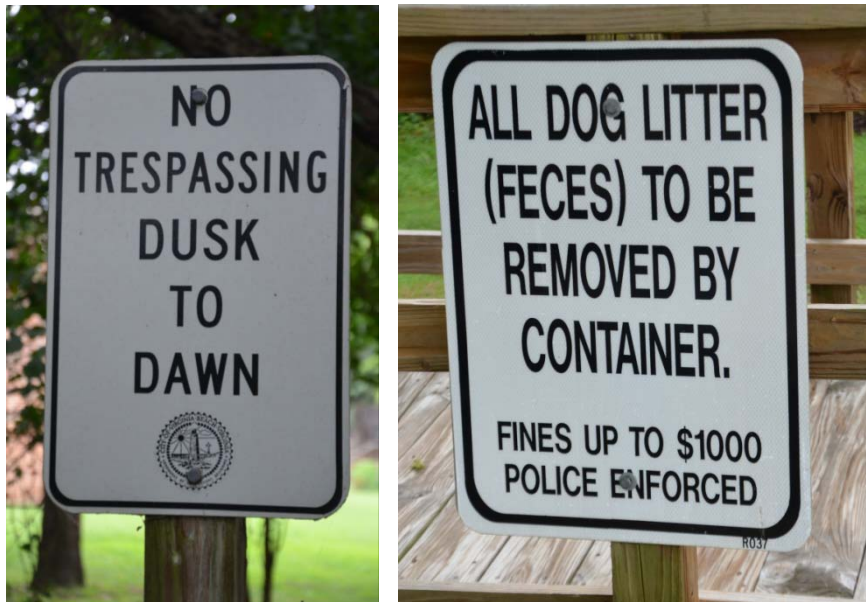
Figure 27. Existing signage fails to specifically address cemetery issues.

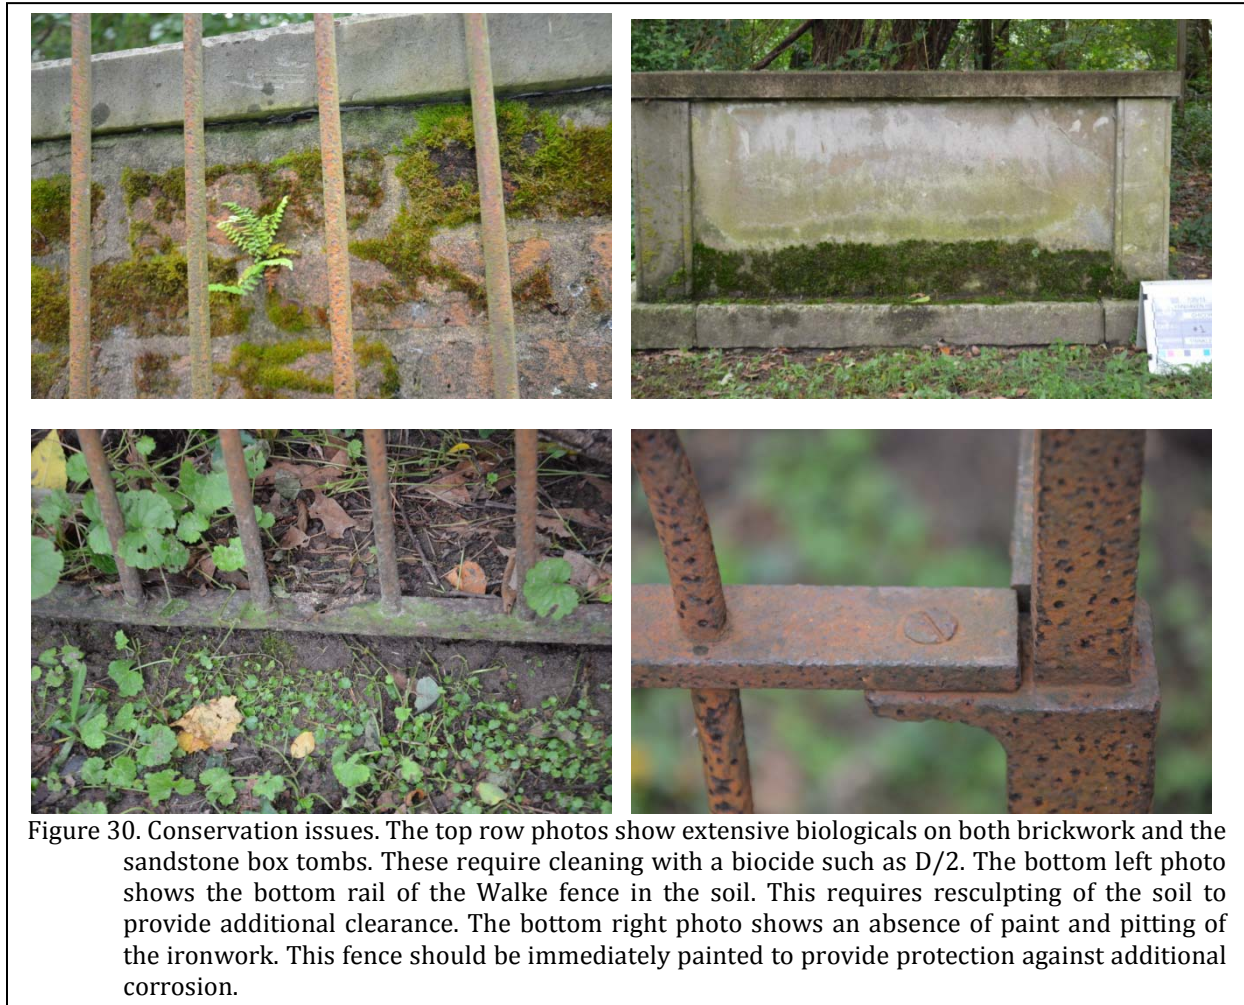
Figure 30. Conservation issues. The top row photos show extensive biologicals on both brickwork and the sandstone box tombs. These require cleaning with a biocide such as D/2. The bottom left photo shows the bottom rail of the Walke fence in the soil. This requires resculpting of the soil to provide additional clearance. The bottom right photo shows an absence of paint and pitting of the ironwork. This fence should be immediately painted to provide protection against additional corrosion.

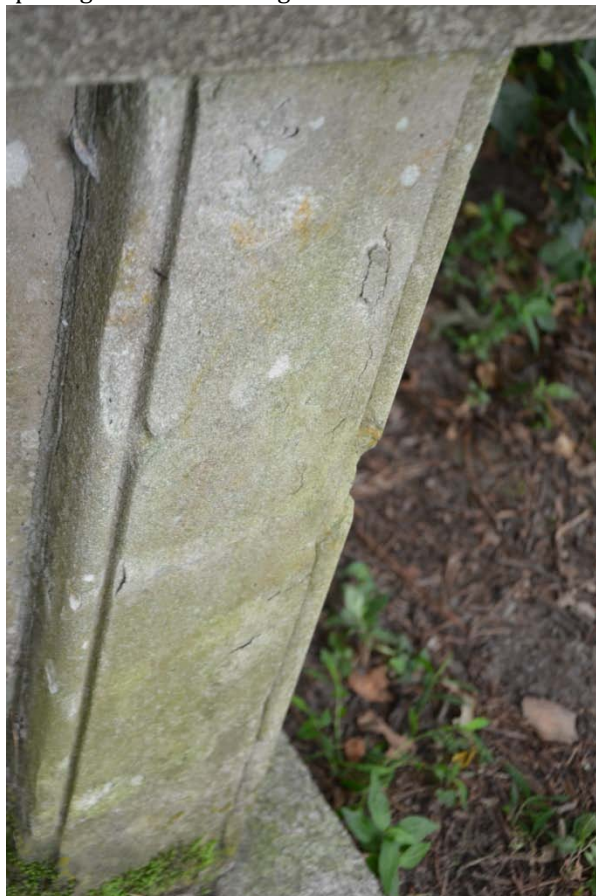
Old break on southwest leg:

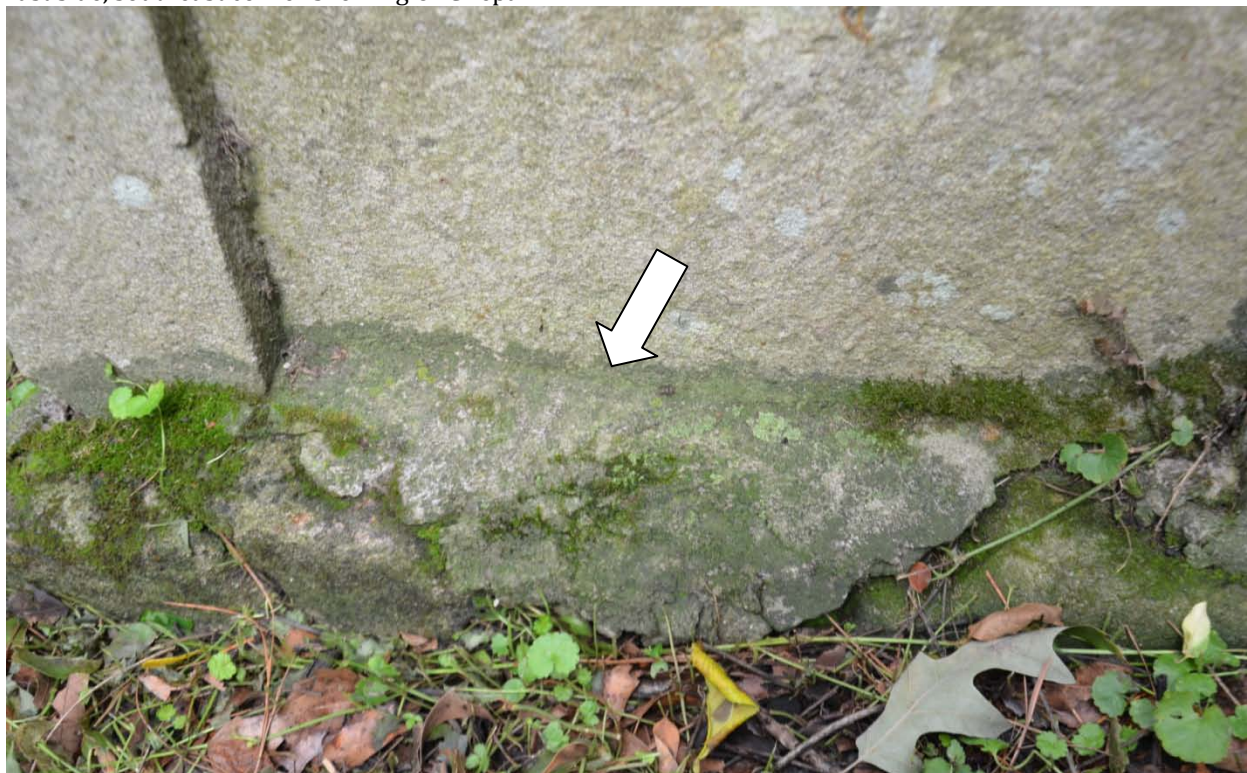
South side, southeast leg, set in OPC:

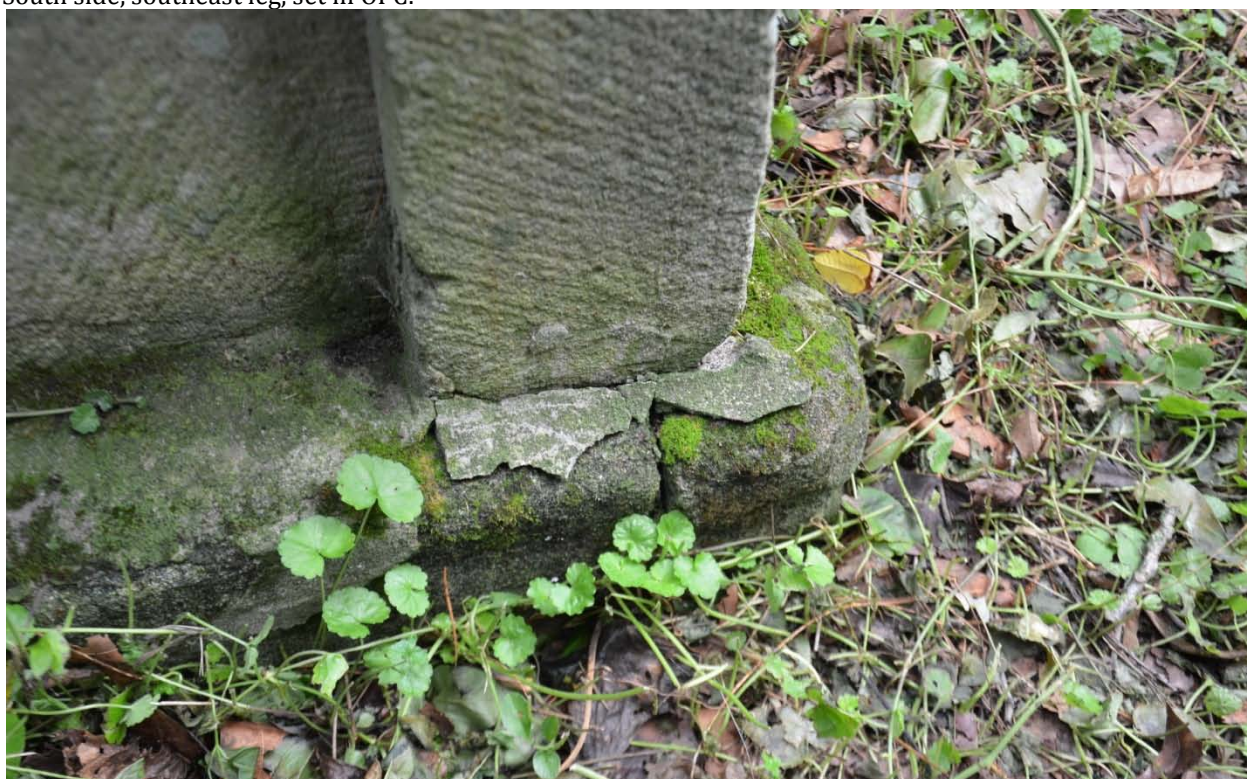
South side, southwest corner showing crack in corner support and spalling (note also vegetation):

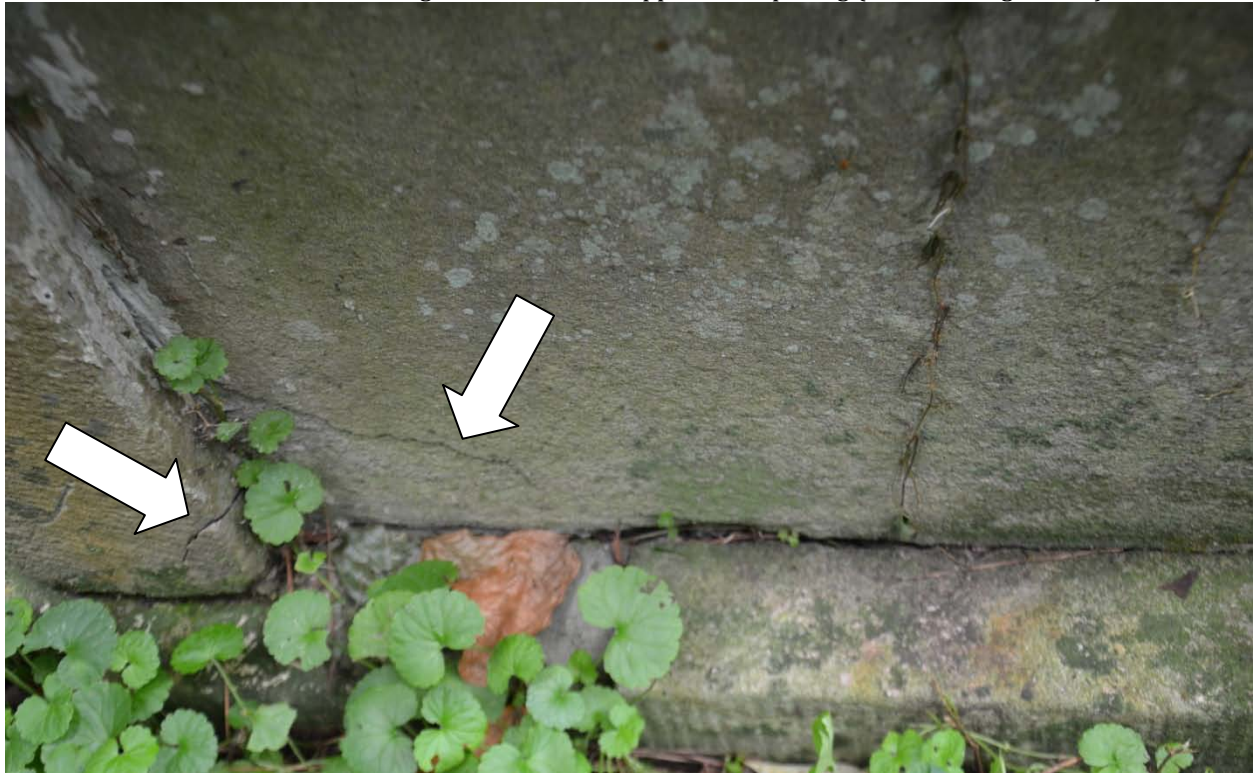
Spalling west side base:

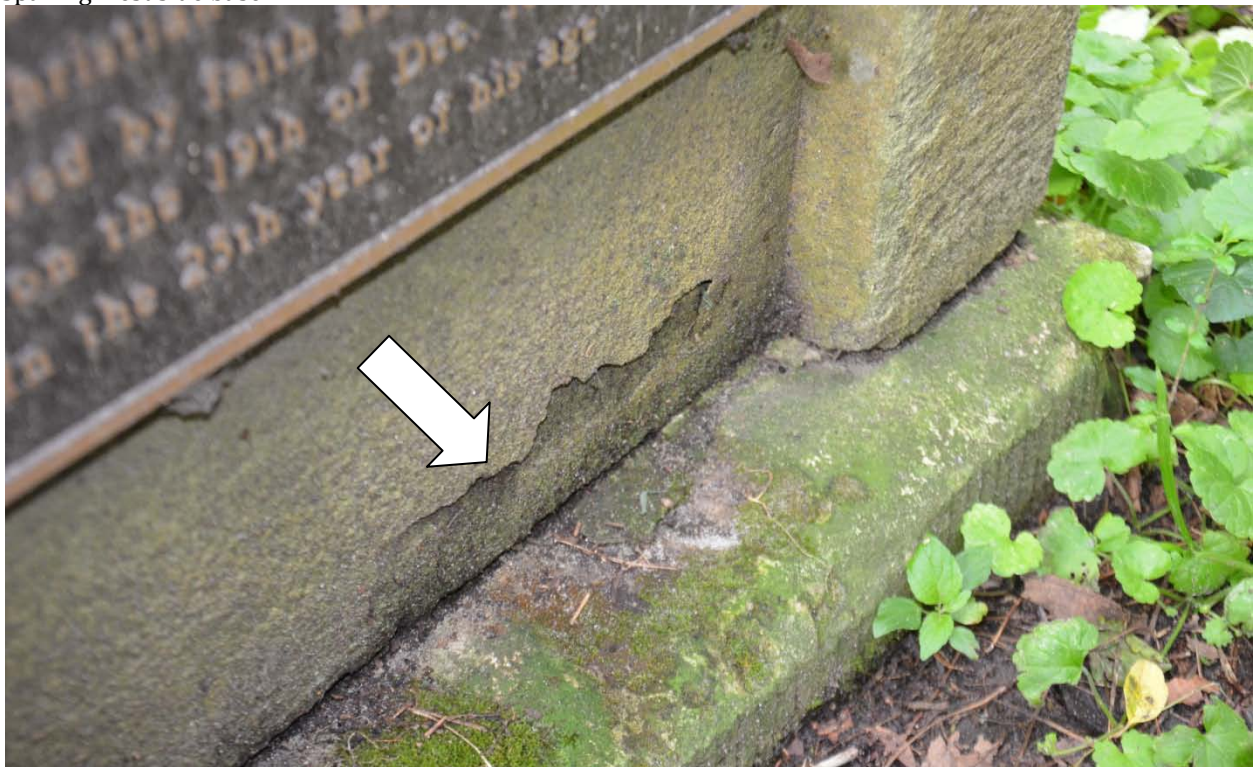
East side, northeast leg, OPC repair:

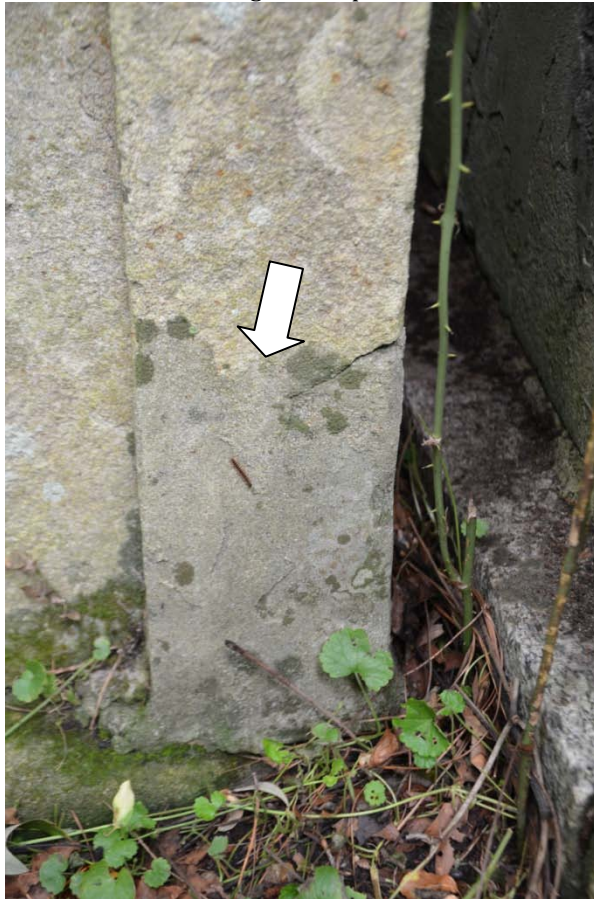
South side, southwest leg showing OPC:

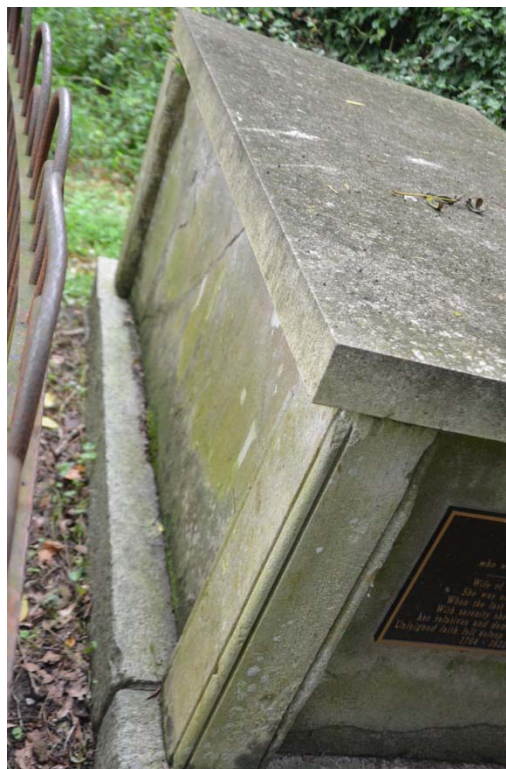
Spalling on north side, center panel and right support leg:

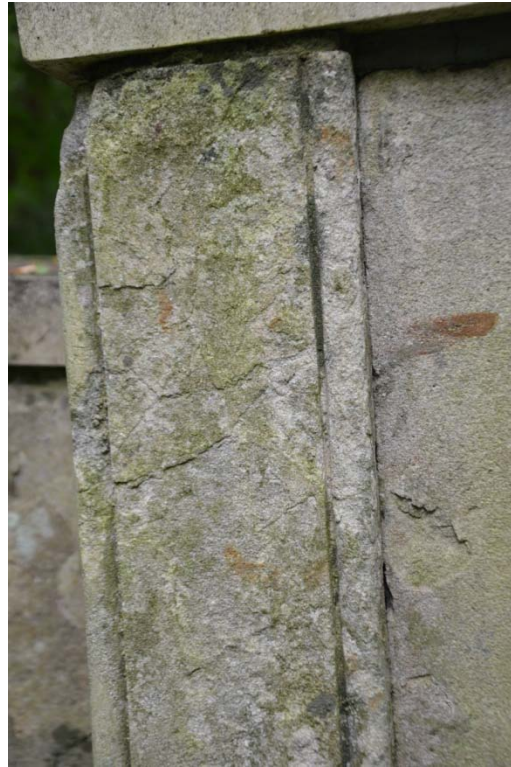
East side, northeast corner showing OPC repair and cast ledger set on thick OPC for leveling:

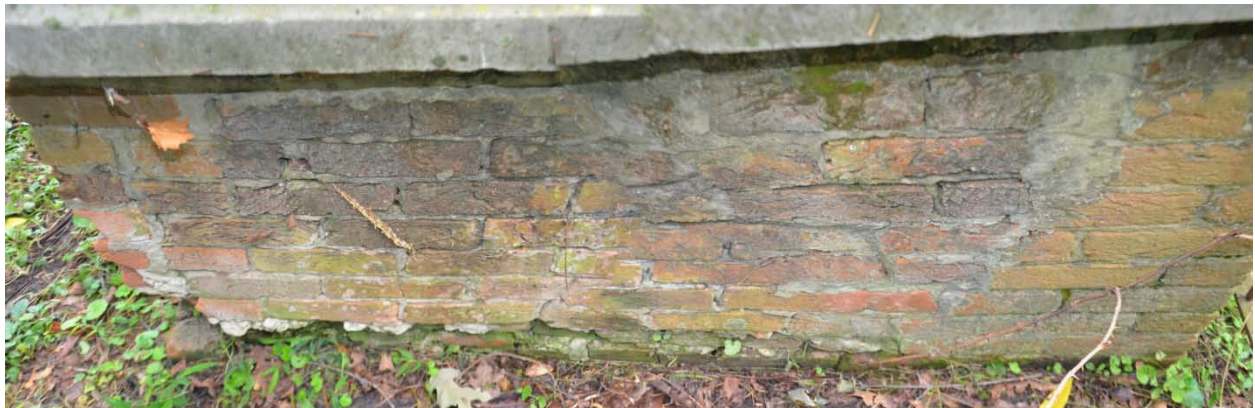
West side, southwest corner showing damage:

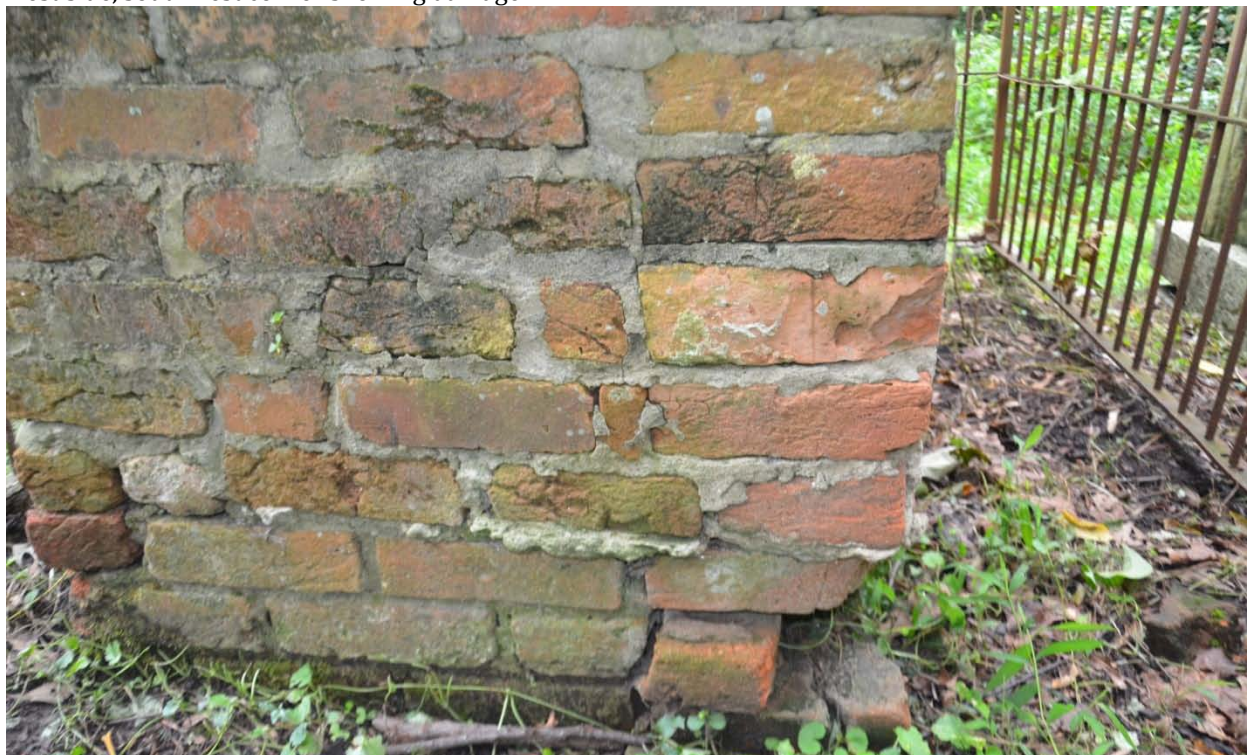
Southwest corner showing displacement, damaged brick, and very poor workmanship:

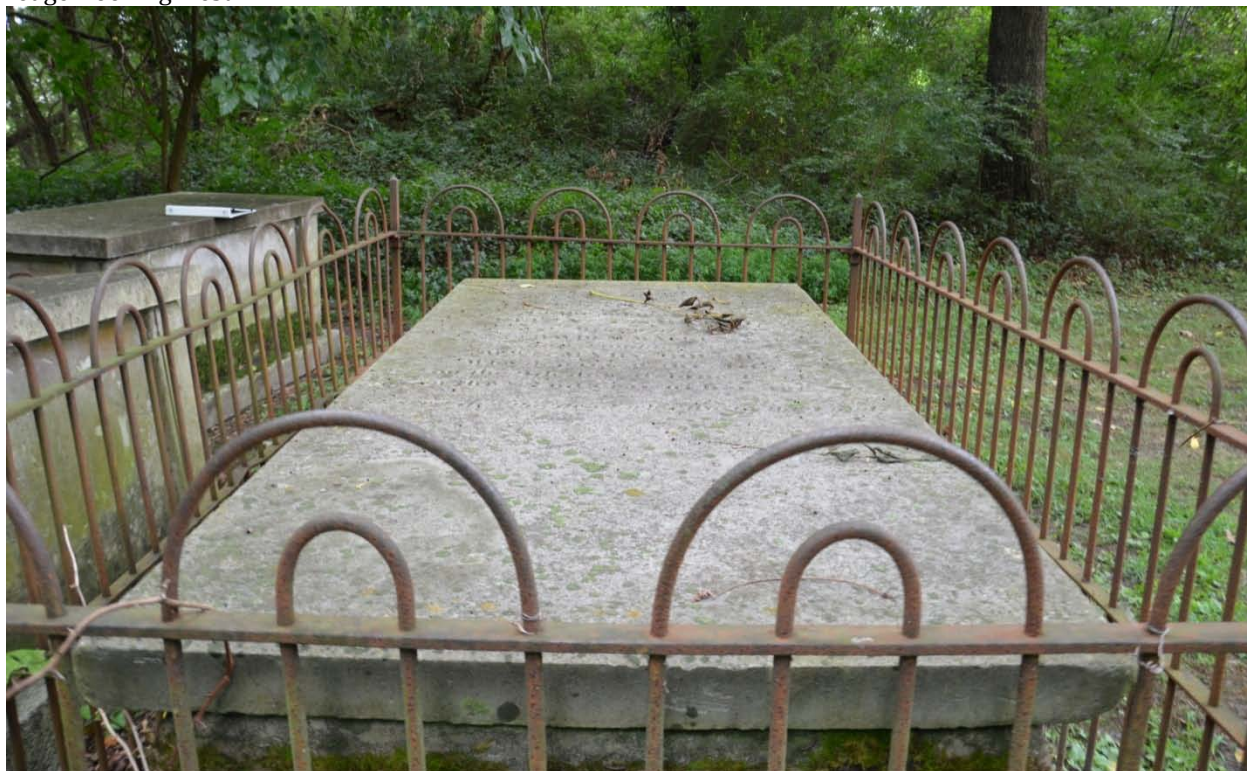
Cracks in ledger, north side:

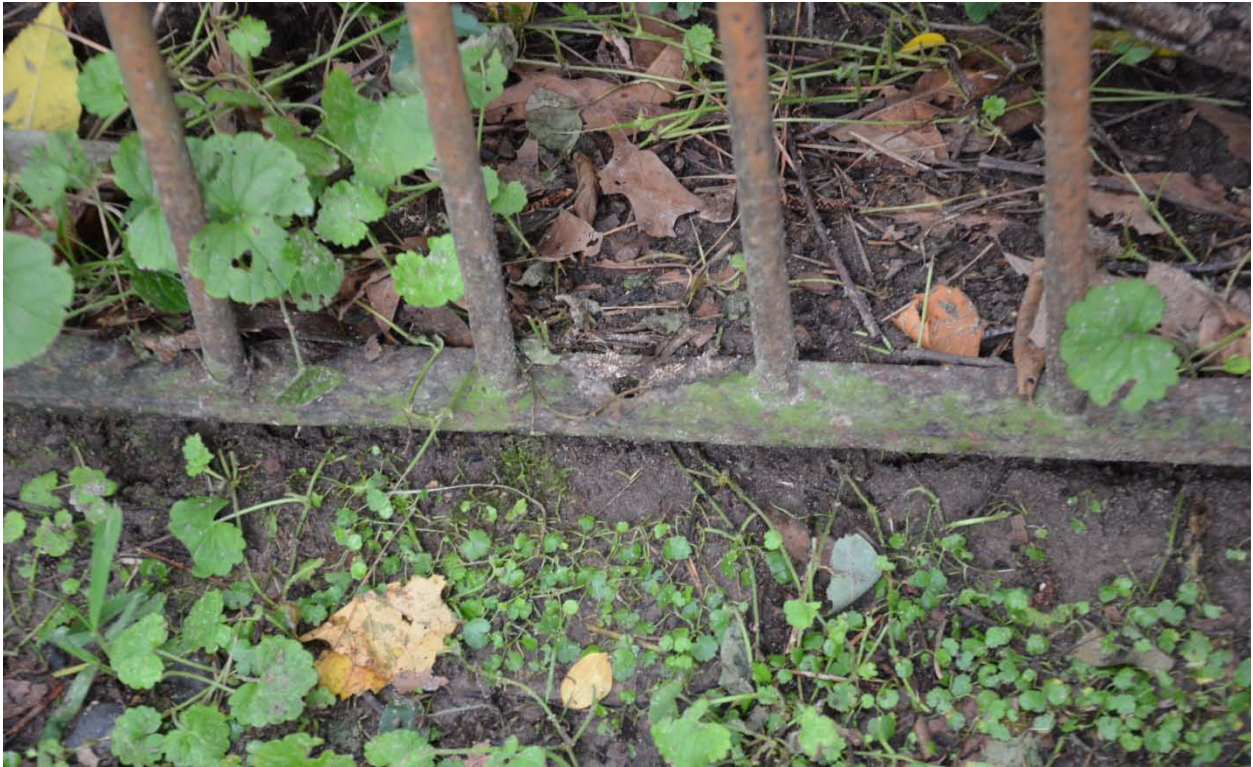
North side, fence bottom rail buried in soil:

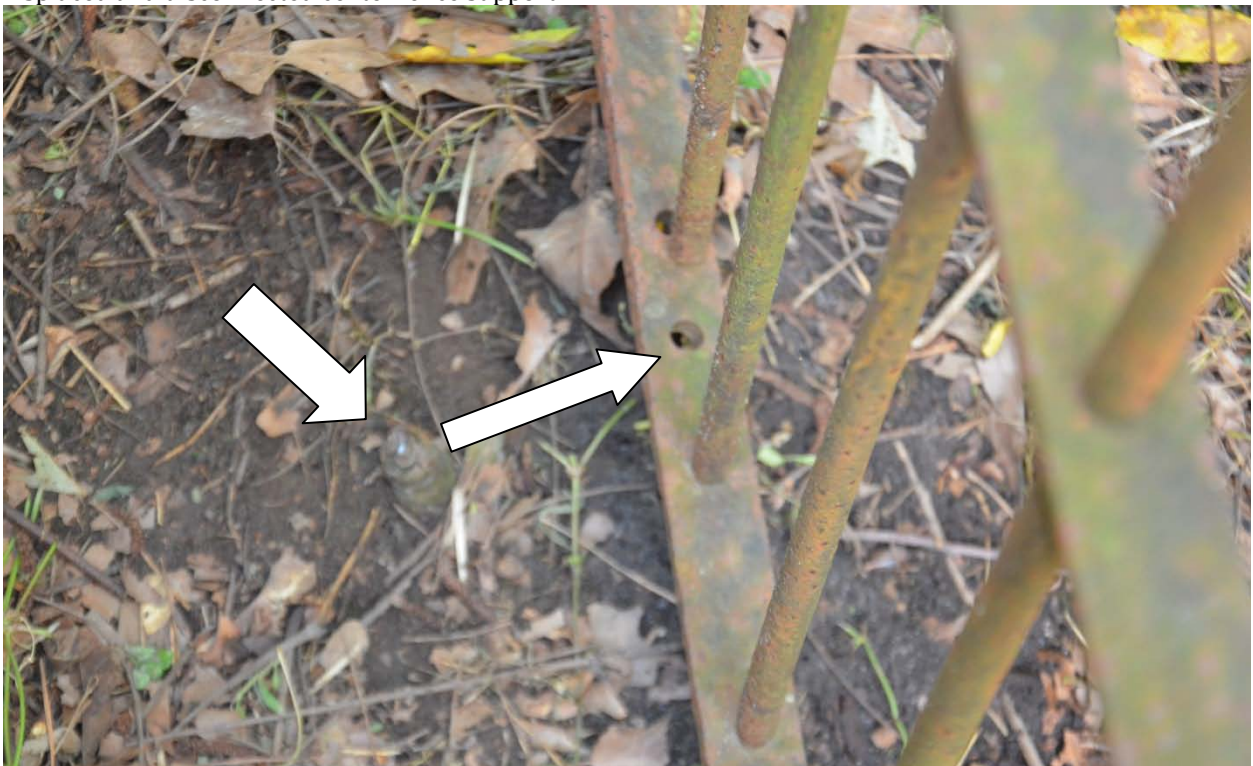
Displaced and disconnected center fence support:

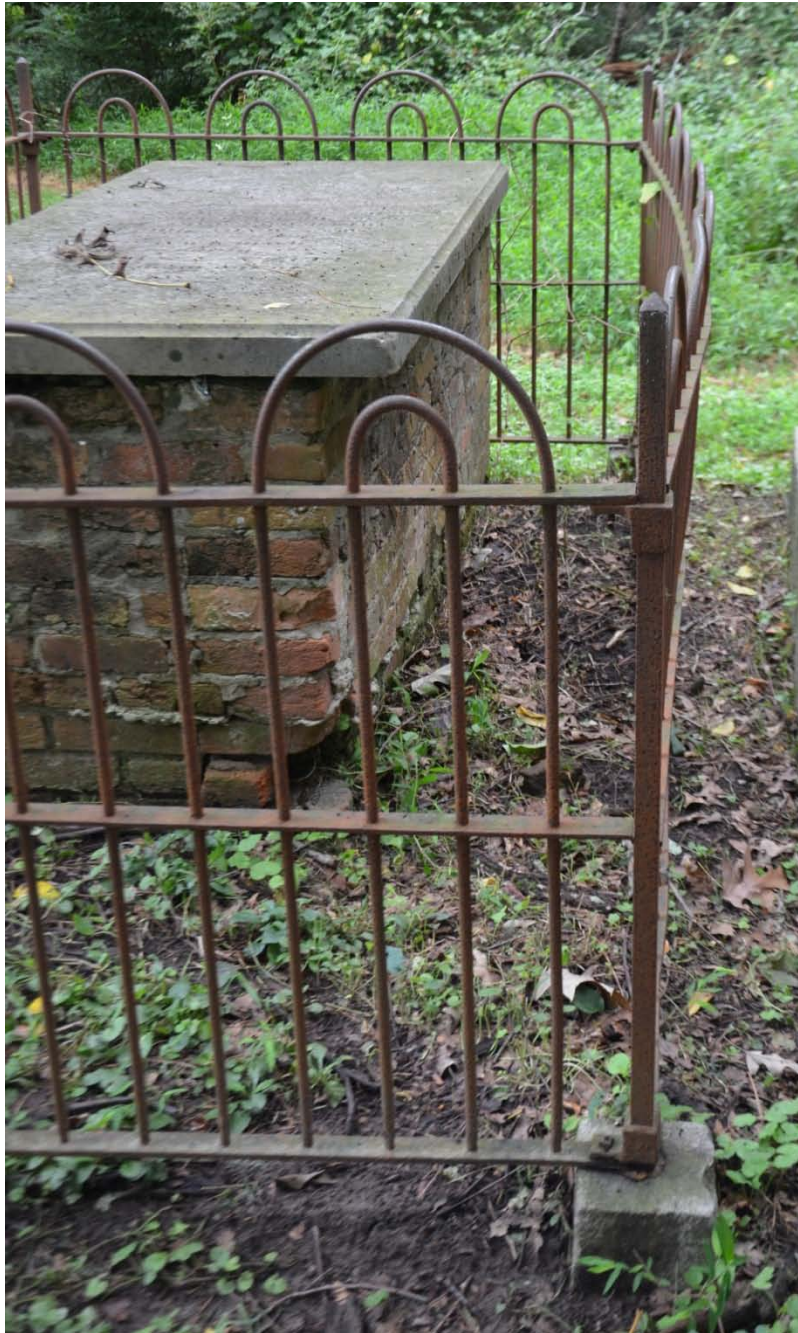
Bend in south side of fence:
